Appendix A: Chicago Z5538

Field Notes and Pictures

Utility: ComEd Investigators: J. Stutsman & J. Spencer

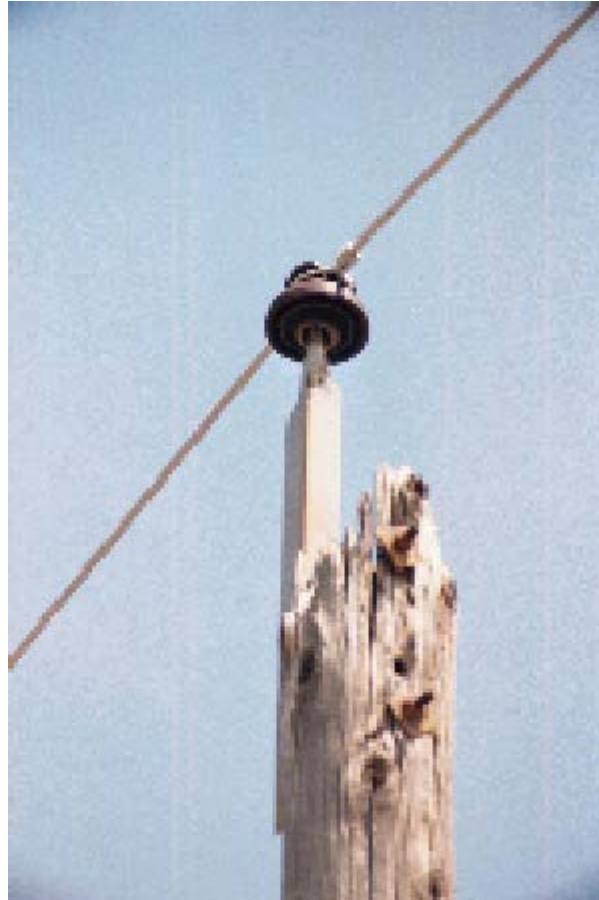
| Feeder | Voltage | Location | Date | Description |
|---|---|---|---|---|
| Z5538 | 12kV | Chicago (Hegwish) | 8/6/01 | Bad pole top in alleyway south of 131st St. between S Baltimore Av & S Brandon Av 2nd pole north from Transformer; Can see daylight thru top by bolt; 12kV – See Picture A1 |

Bad Pole top in alleyway south of 131st St. between S Baltimore Av and S Brandon Av

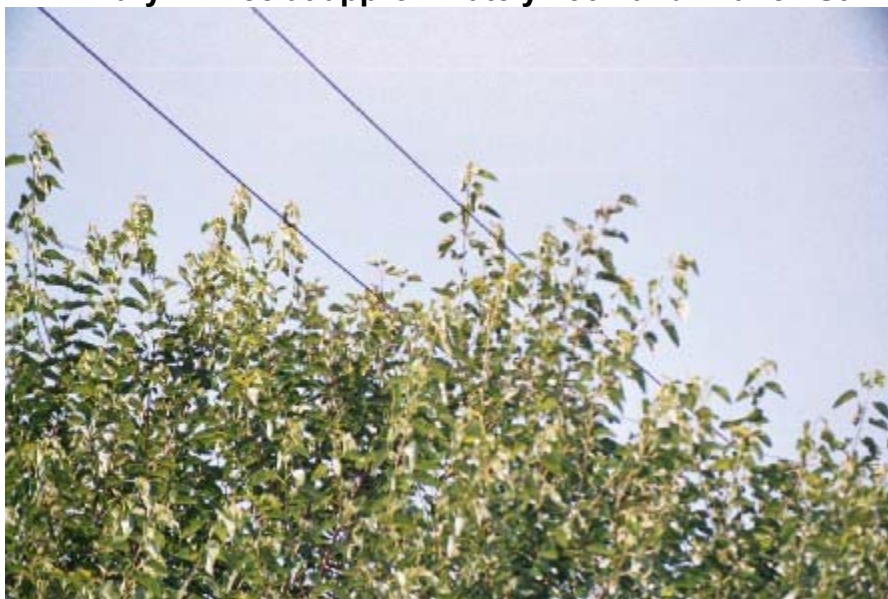
| Z5538 | 12kV | Chicago (Hegwish) | 8/6/01 | Tree Contact -- Primary in tree at approximately 136th & Branch St; Bare Conductor; Pole # 14570; 12kV --See Picture A2 |

Primary in Tree at approximately 136th and Branch St.

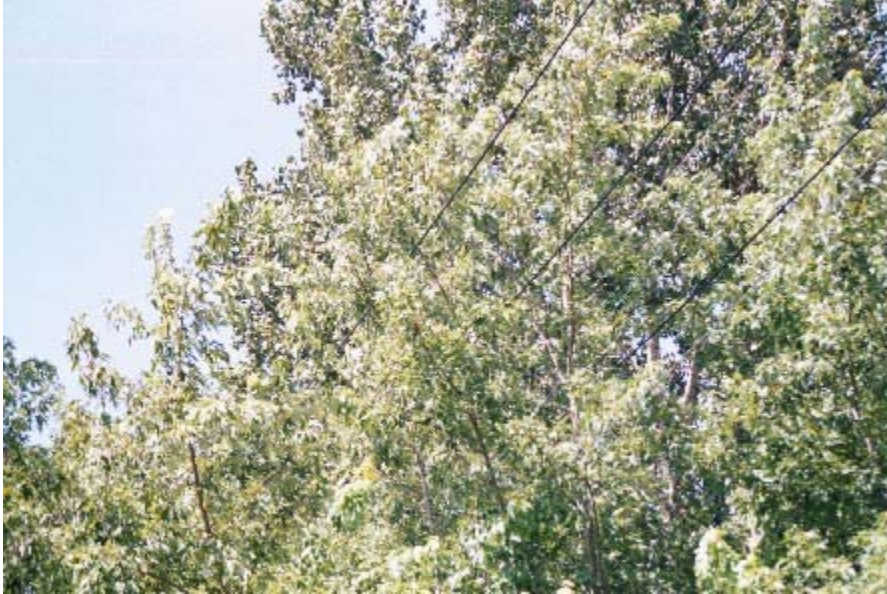
| Z5538 | 12kV | Chicago (Hegwish) | 8/6/01 | Tree Contact -- On Chippewa Ave approx 100 yards northwest of Burnham Av & Chippewa; Tree Clearance and Contact; Line was insulated (Tree Wire); through Silver Maple -- See Picture A3 |

Insulated Line through Silver Maple on Chippewa Ave approximately 100 yards northwest of Burnham Av and Chippewa intersection

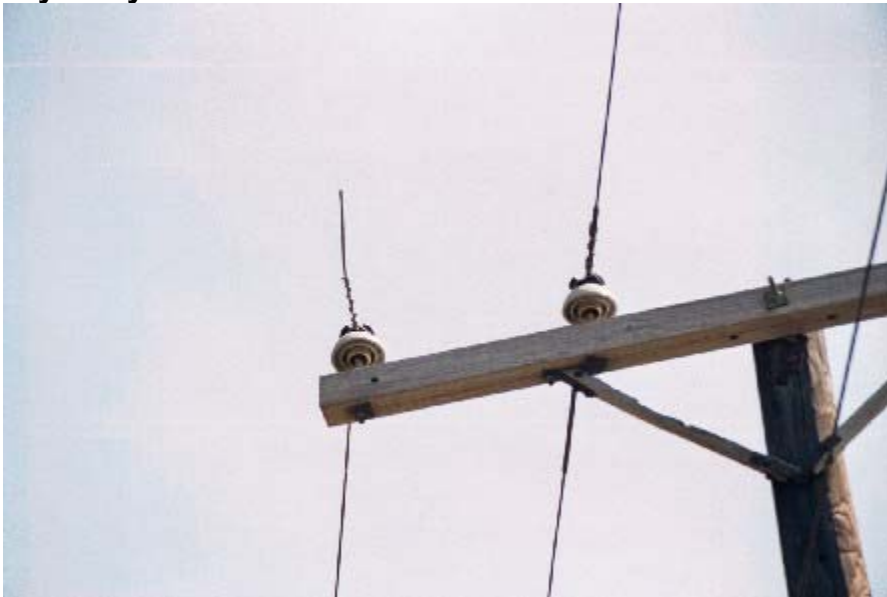
| Z5538 | 12/4kV | Chicago (Hegwish) | 8/6/01 | Missing Phase Wire and Bad Brace -- On Brainard Av approximately 150 yards SE of Brainard Av & Burnham Av |
| Z5538 | 12/4kV | Chicago (Hegwish) | 8/6/01 | Missing phase wire on roadside phase; north brace (roadside) is bad --See Picture A4 |

Missing Phase Wire and Bad Brace on Road-side (north) at Brainard Av approximately 150 yards southeast of Brainard Av and Burnham Av intersection

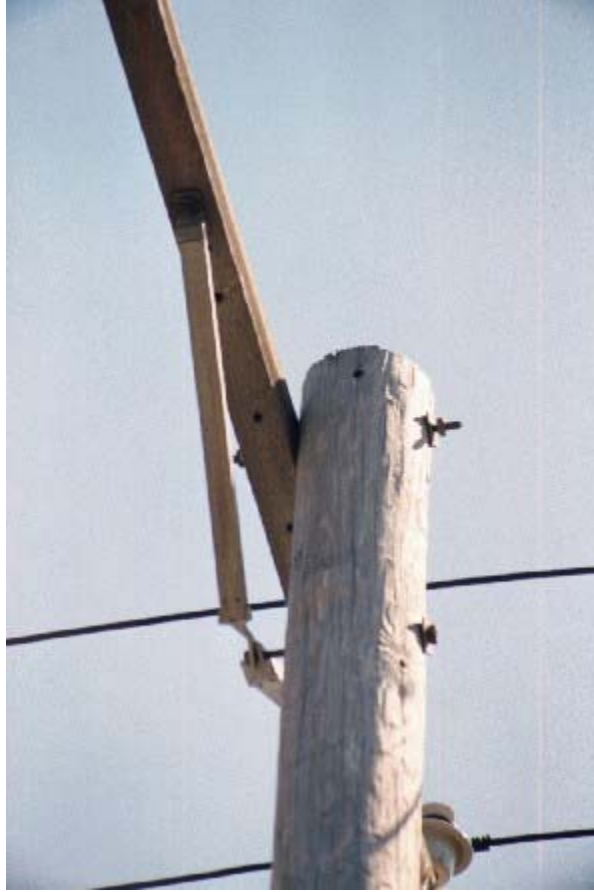
| Z5538 | 12kV | Chicago (Hegwish) | 8/6/01 | Brace lose from pole -- On E 134 St approx 485 yards east of S. Avenue K; Brace bolt lose with brace pulled away from pole -- See Picture A5 |

Brace bolt is loose and brace is pulled away from pole on E 134 St approximately 485 yards east of S. Avenue K
